CORROCOAT CASPIAN

CASE STUDY

<u>Customer:</u>	Altynalmas
<u>Equipment:</u>	6 sorption tanks
<u>Location:</u>	Aktogai (Pustynnoe) goldmine, Karaganda region, Kazakhstan
<u>Dates:</u>	February – March 2020
<u>Environment:</u>	chemically aggressive (pulp, alkali, ph - 11)
<u>Problem:</u>	chemical corrosion with a lot of corrosion pits on the walls and bottom of the tanks, erosion in the feed channels, pipes and pacifiers
<u>Solution:</u>	Lamination of the pacifiers (with fiberglass and laminating resin); First coat – Polyglass VEF vinyl-ester glassflake coating at 750 microns; Second coat – abrasion resistant vinyl-ester glassflake coating Polyglass VEF WR (wear-resistant) at 750 microns.

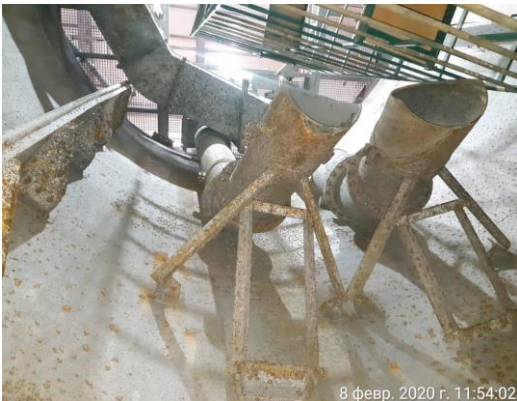
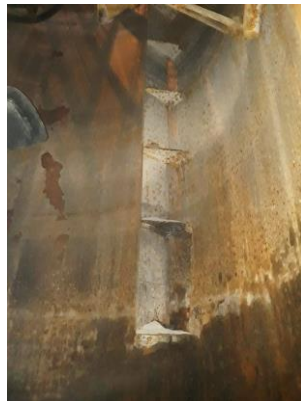
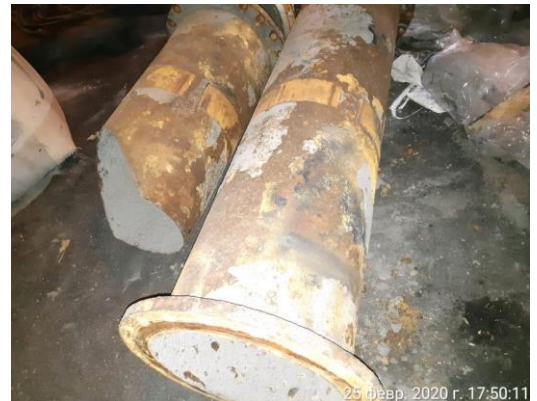
Sorption tanks before repair:

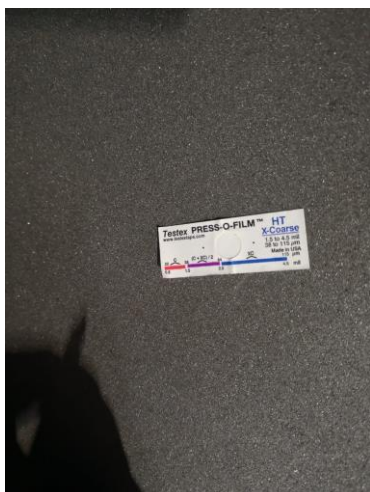
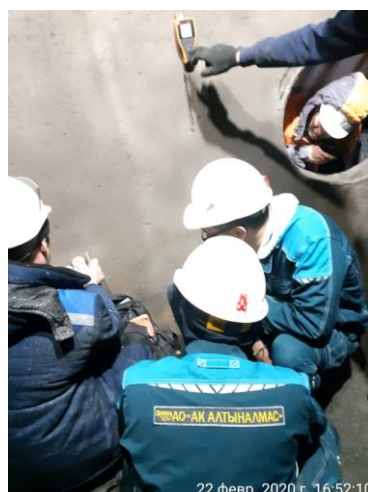
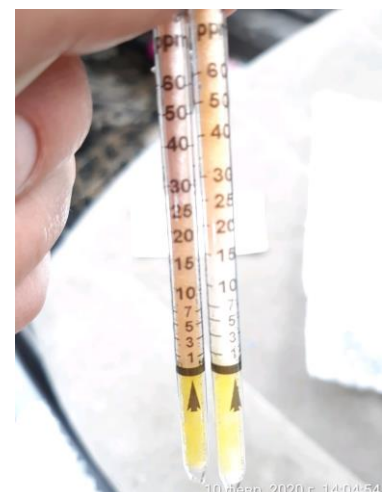
Quality control of blasted surface:

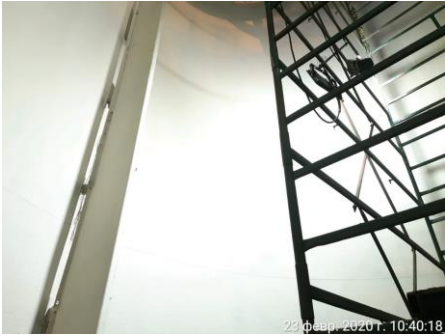
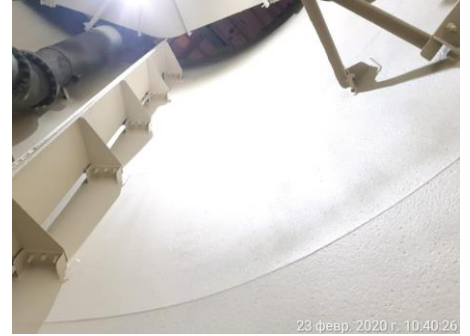
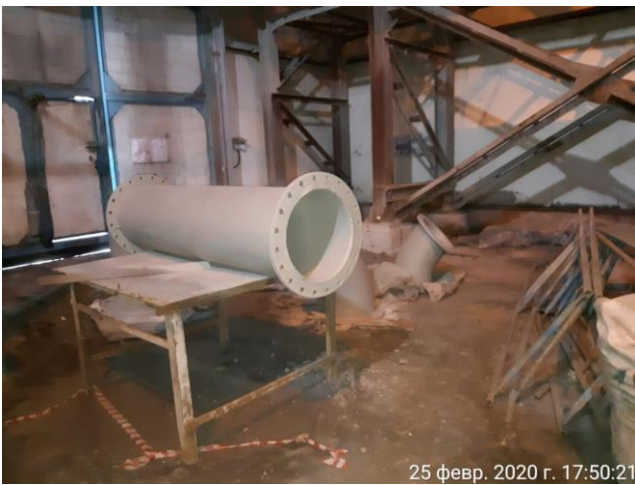
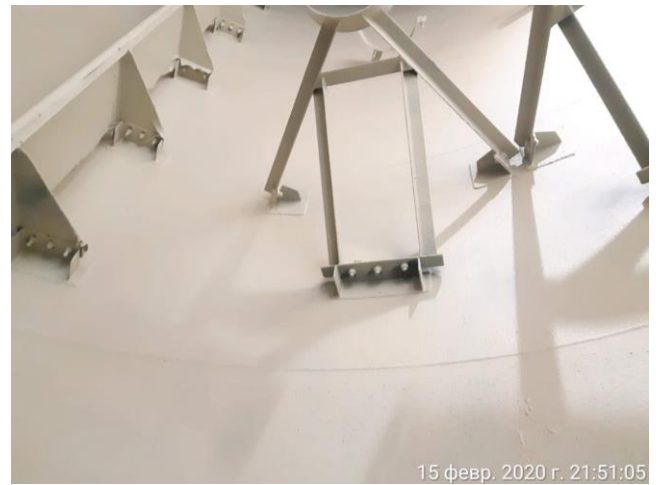
Coated and repaired tanks:

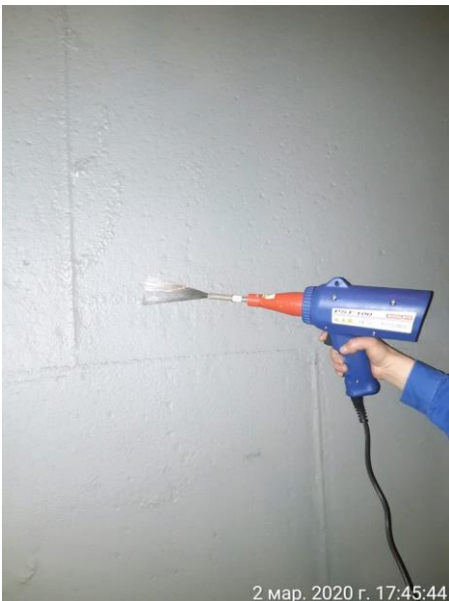
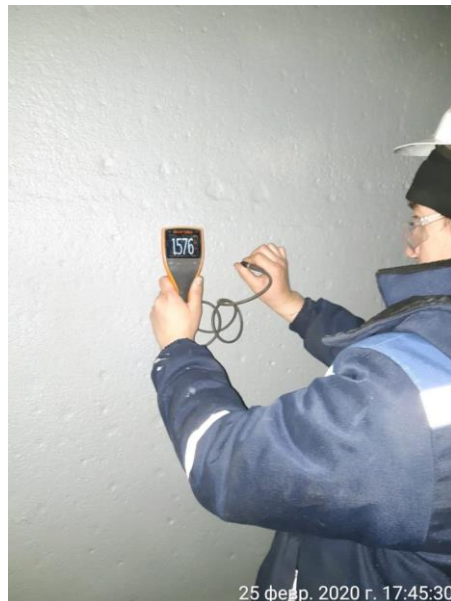
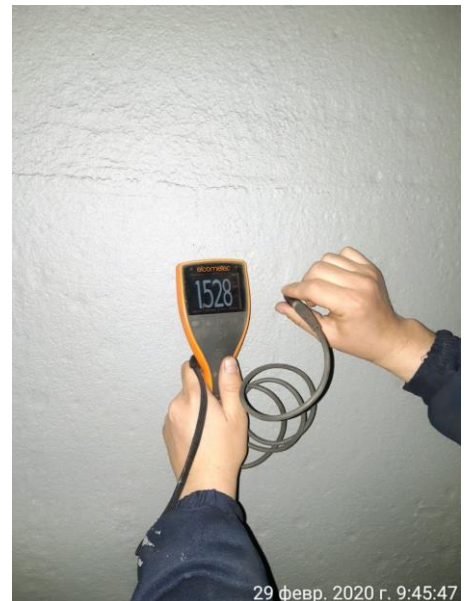
Final quality control inspection:
