CASE STUDY

Customer: Karazhanbasmunai

Equipment: Oil separators V-200m3

Location: Karazhanbas oilfield, Mangistau region, Kazakhstan

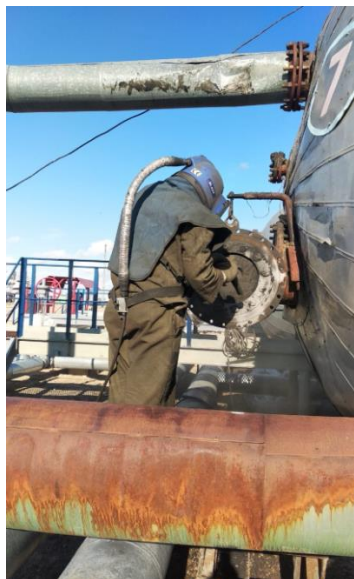
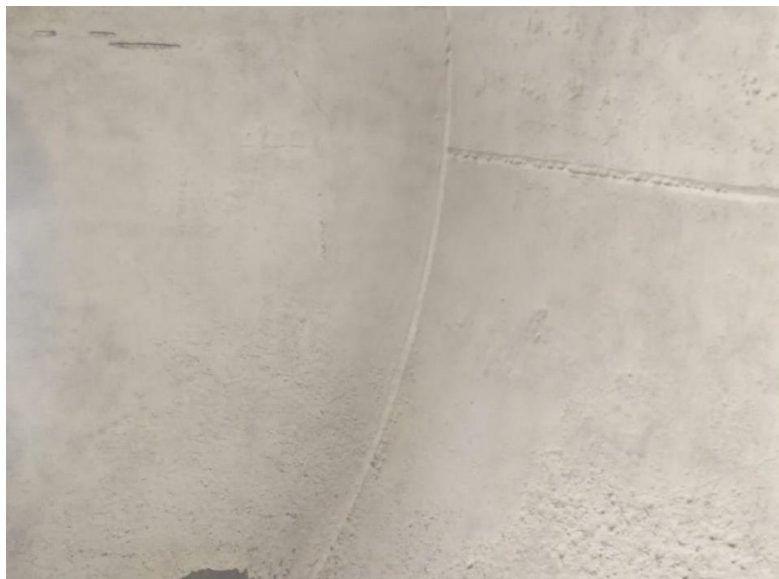
Grit blasting:

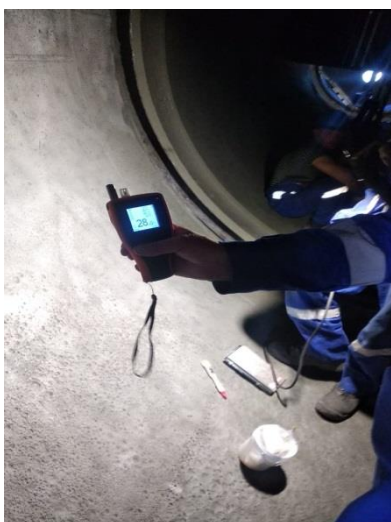
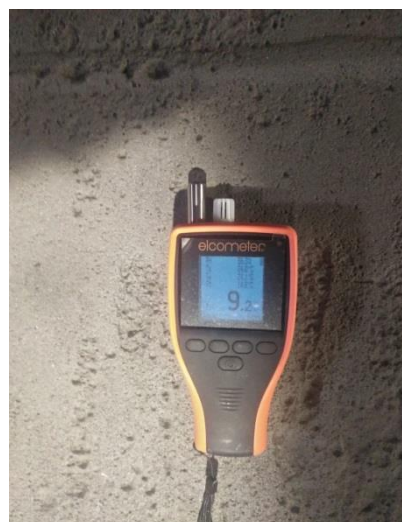
Blasted surface quality control:

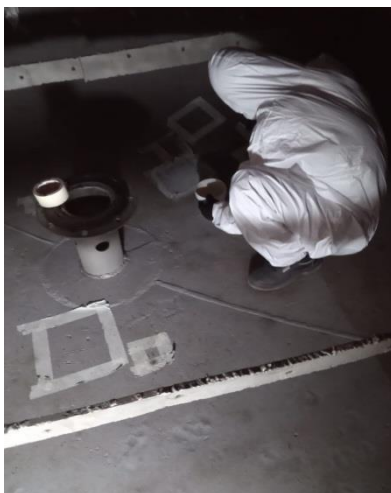
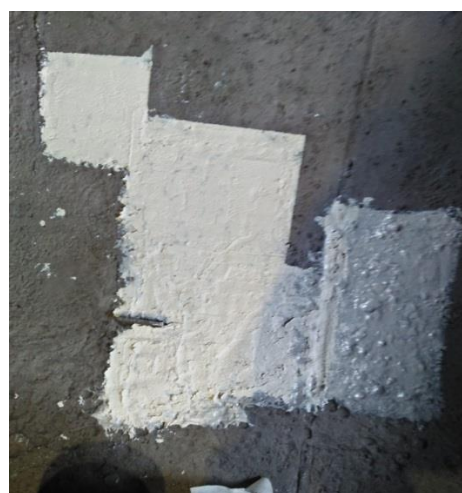
Repair of corrosion pits:

Coating: Corroglass 600 (for corrosion pit repair), Polyglass VEF at 1000 microns

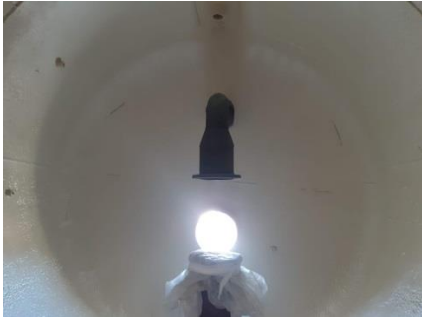
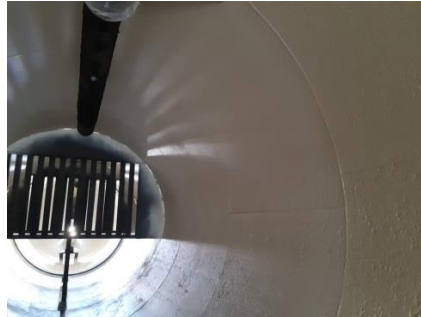
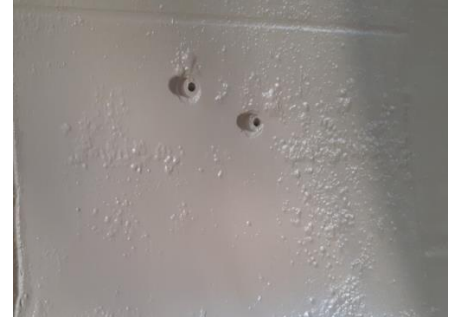
After application of Polyglass VEF at 1000 microns:

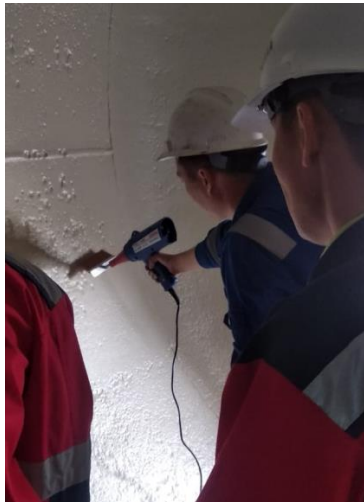
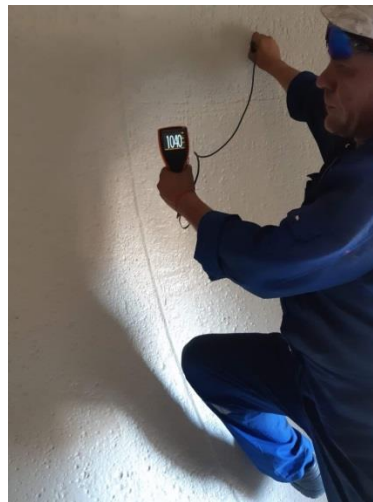
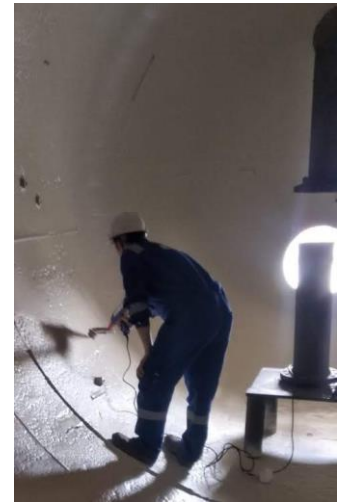
Final inspection:
