CORROCOAT CASPIAN

CASE STUDY

Customer: Alprof (aluminum profiles manufacturer)

Equipment coated: 2 rinsing baths

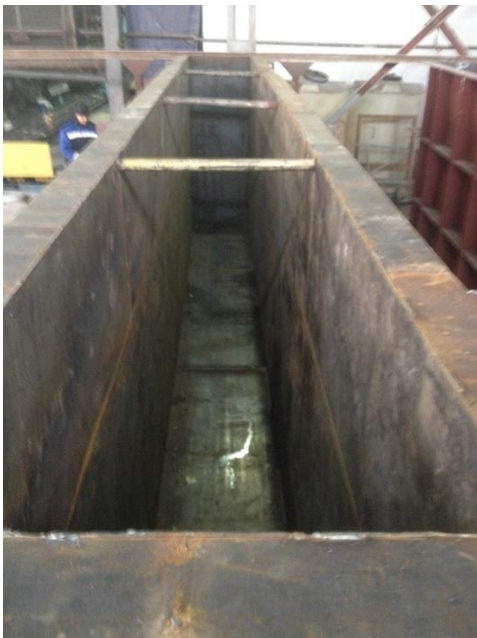
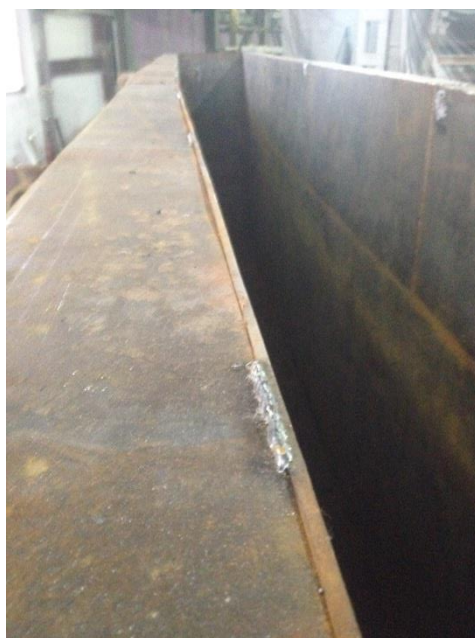
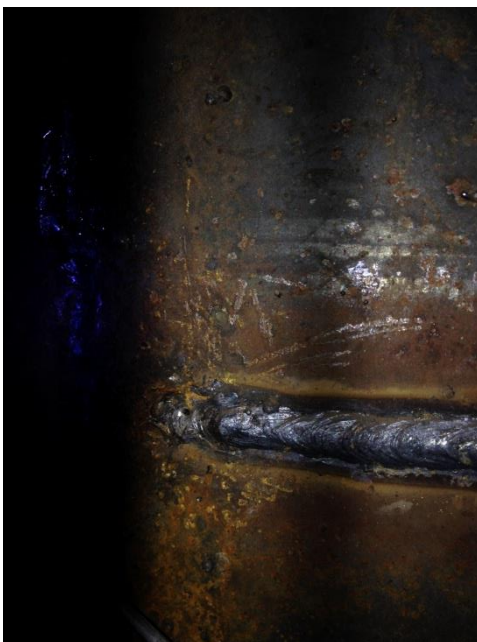
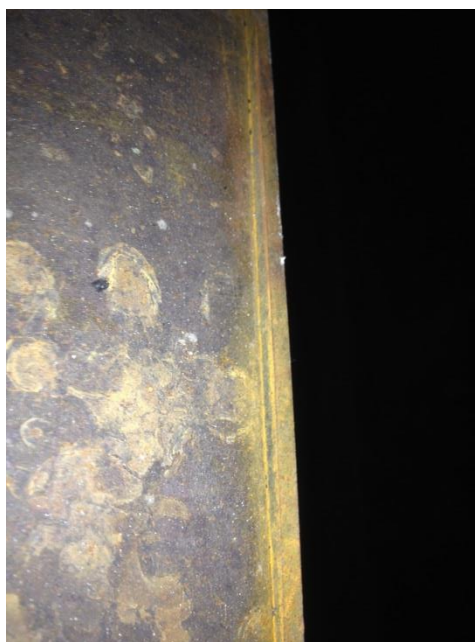
Rinsing baths before coating:

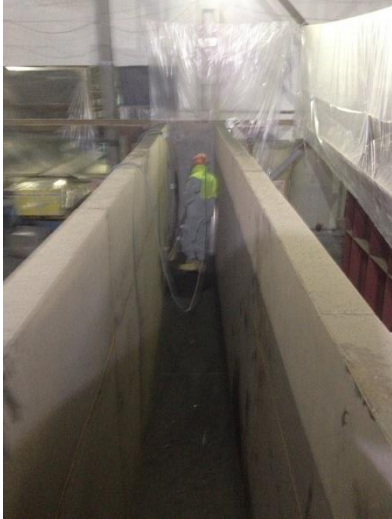
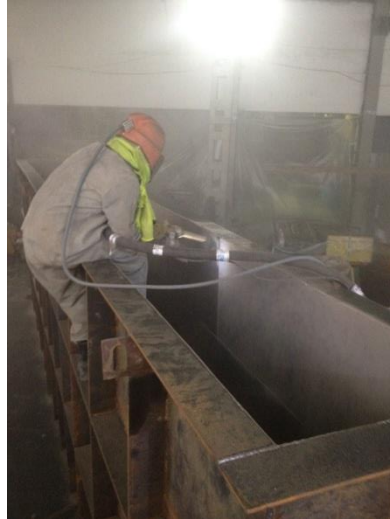
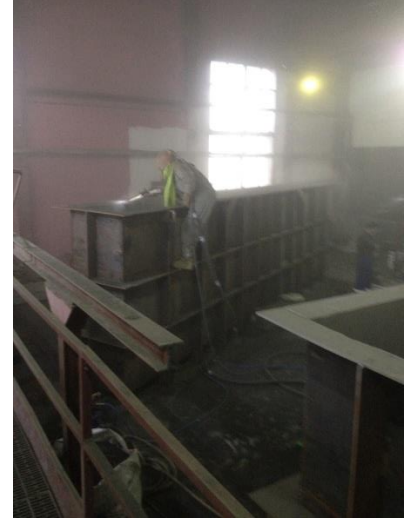
Grit blasting:

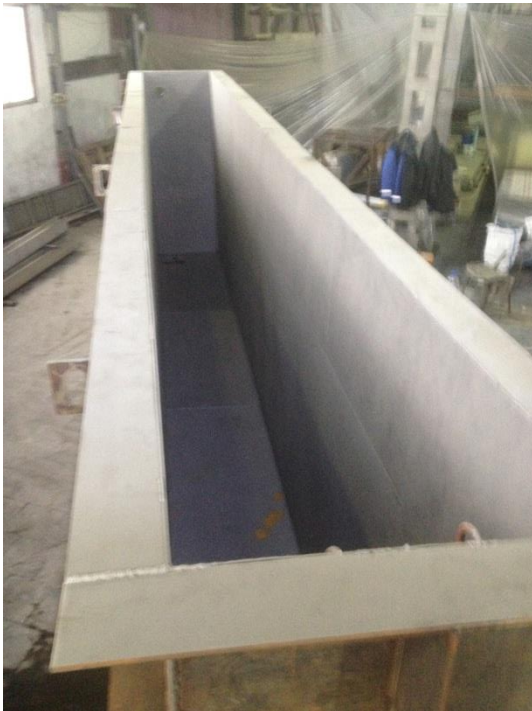
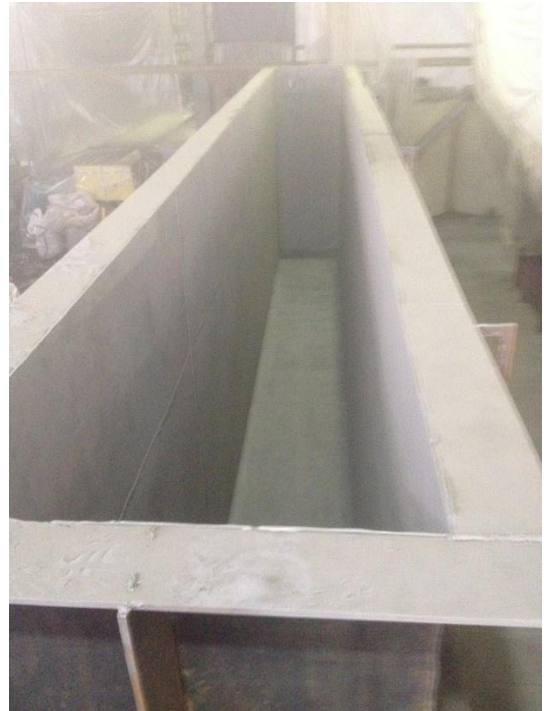
Blasted baths:

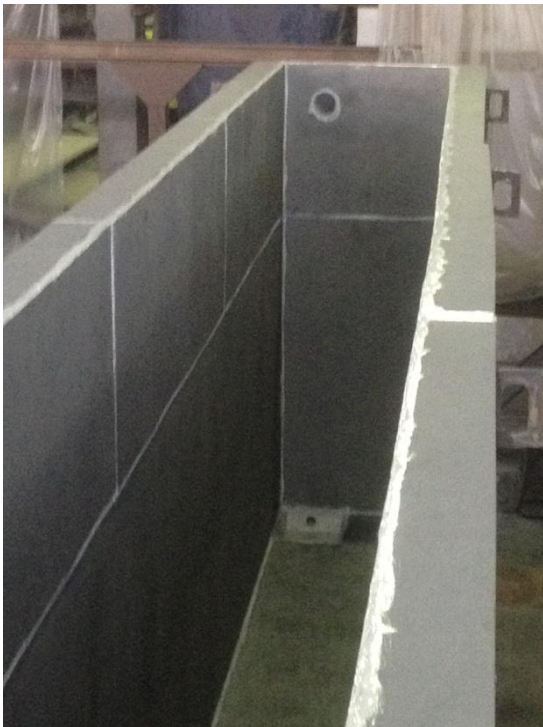
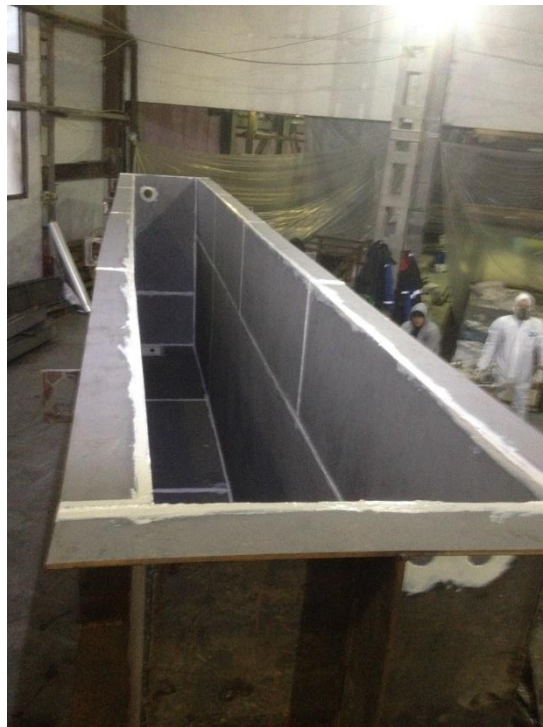
Stripe coating (Corroglass 632 material)

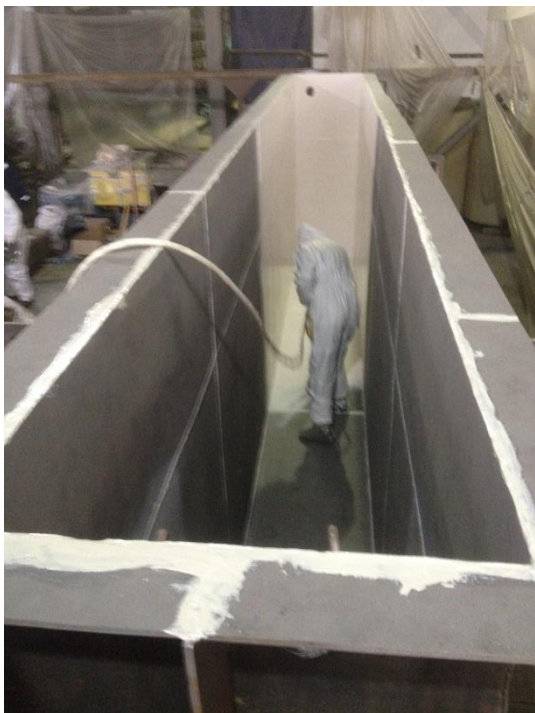
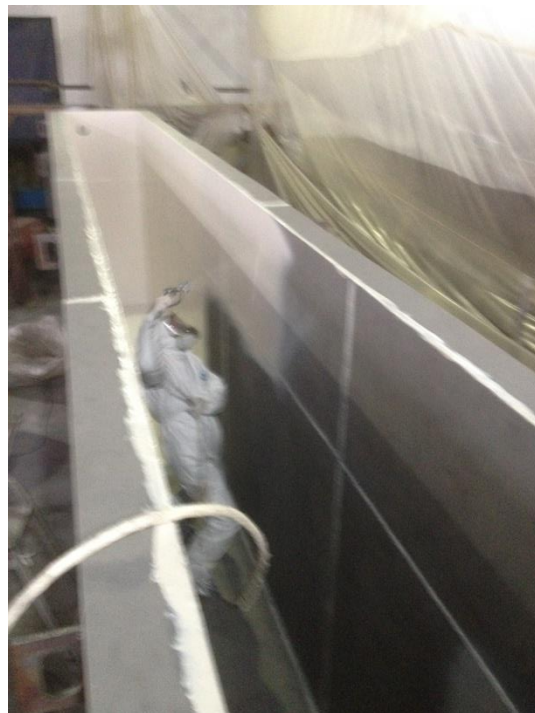
Full coating (Polyglass 100 material)

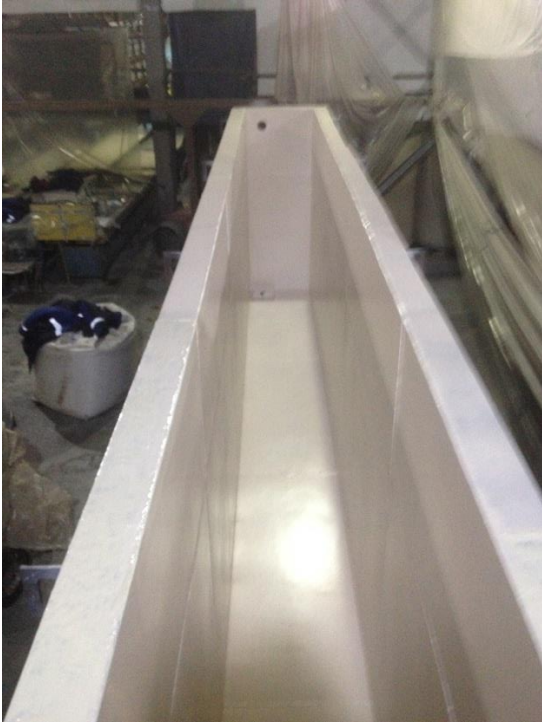
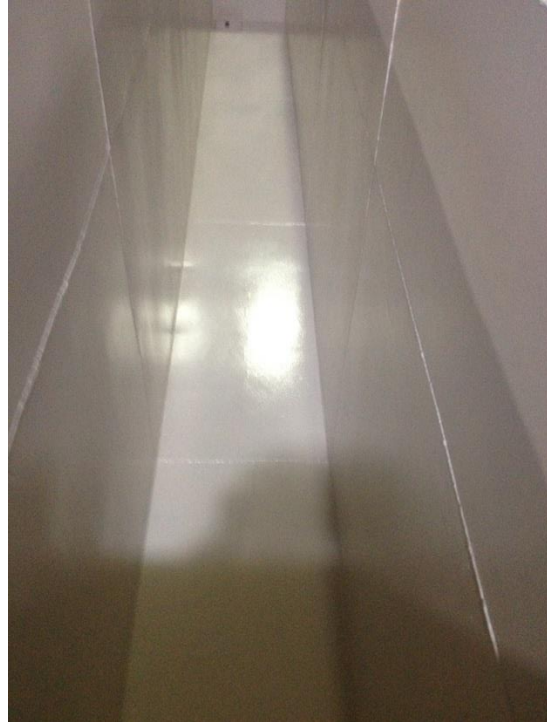
Coated baths:

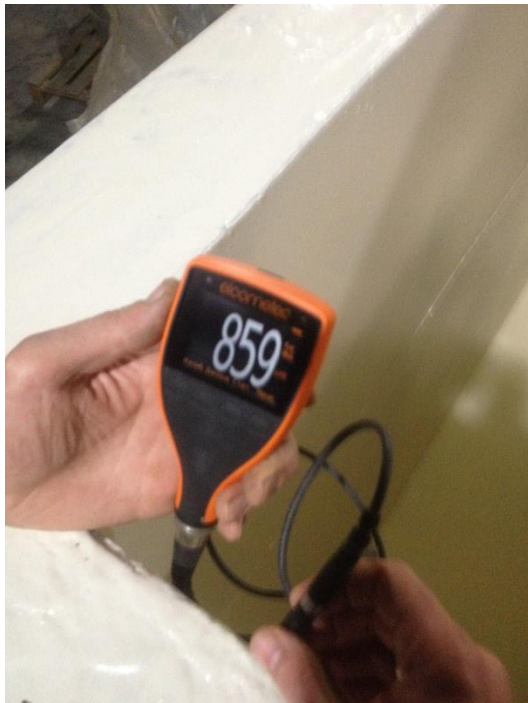
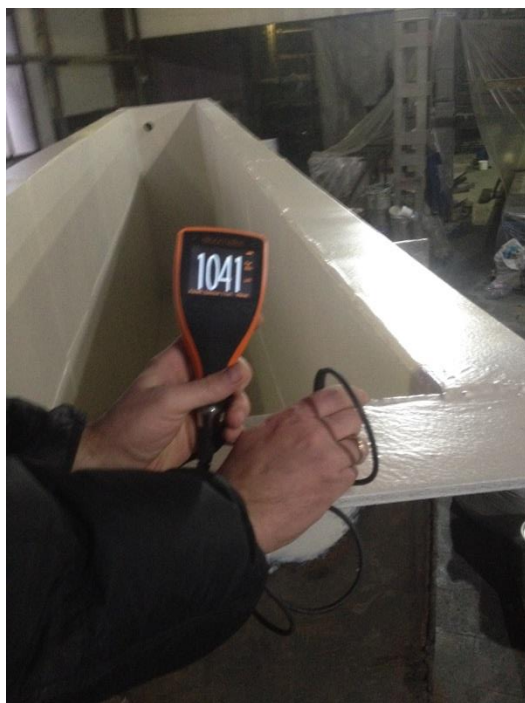
DFT measurement:
