CORROCOAT CASPIAN

CASE STUDY

<u>Customer:</u>	Eurasian Foods Corporation, Almaty
<u>Equipment:</u>	Soapstock heating tank
<u>Location:</u>	Almaty, Kazakhstan
<u>Dates:</u>	January 2020, January 2016
<u>Environment:</u>	Soapstock, sulfuric acid (30% concentration), temperature upto +95°C
<u>Problem:</u>	Aggressive chemical corrosion at high temperatures, deep corrosion pits
<u>Solution:</u>	Repair of all corrosion pits with Corroglass 600 materials; application of thermal-resistant three-component vinyl-ester-urethane material Corrothane XT at 1000 microns, with post-cure

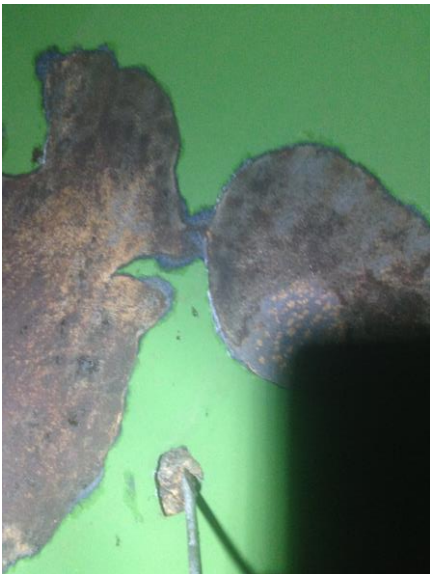
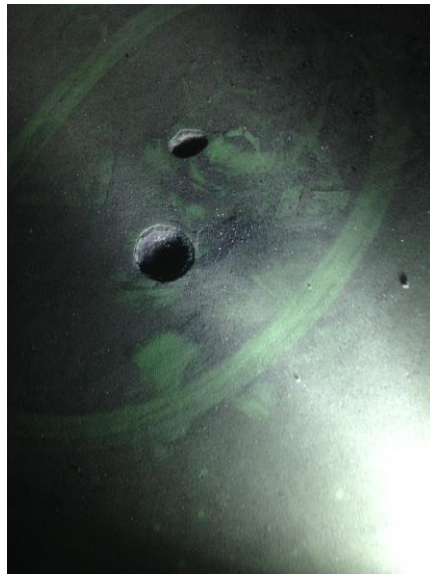
Condition of the soapstock tanks:

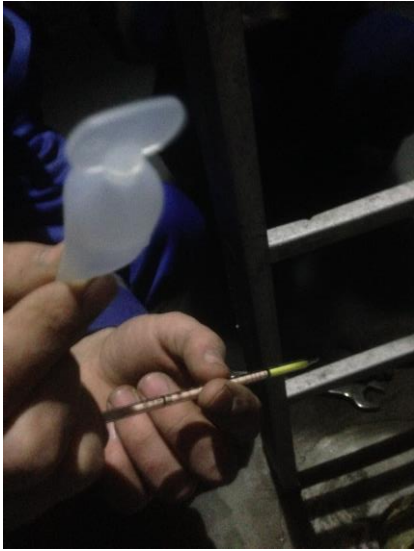
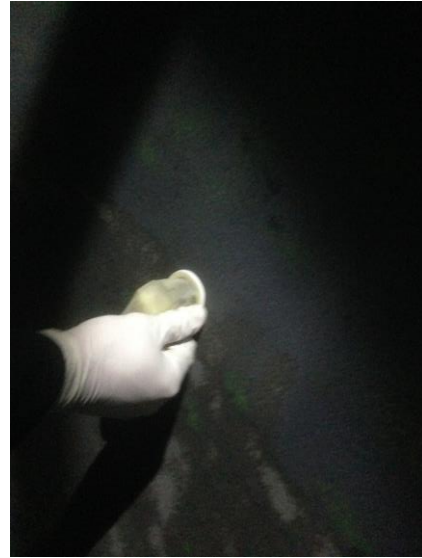
Blasted surface quality control:

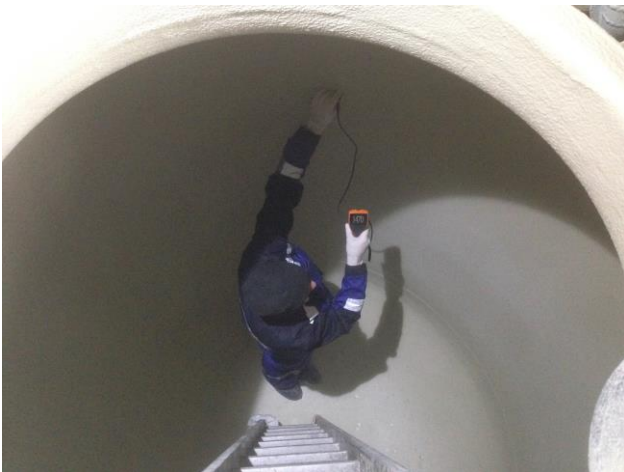
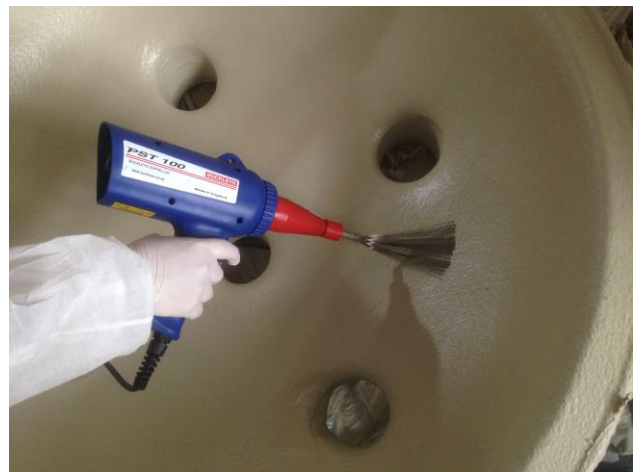
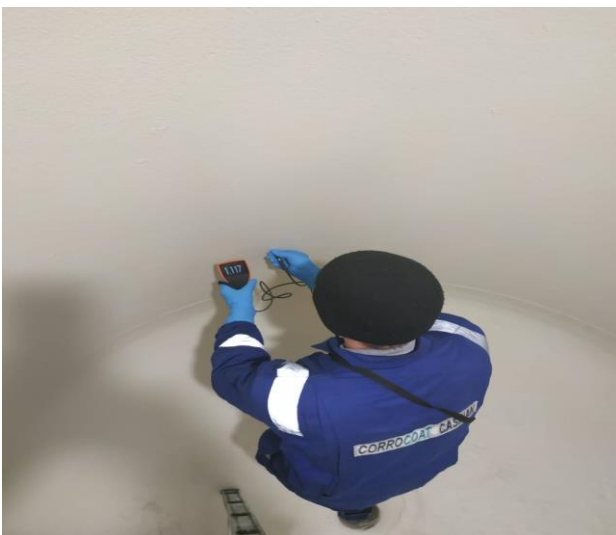
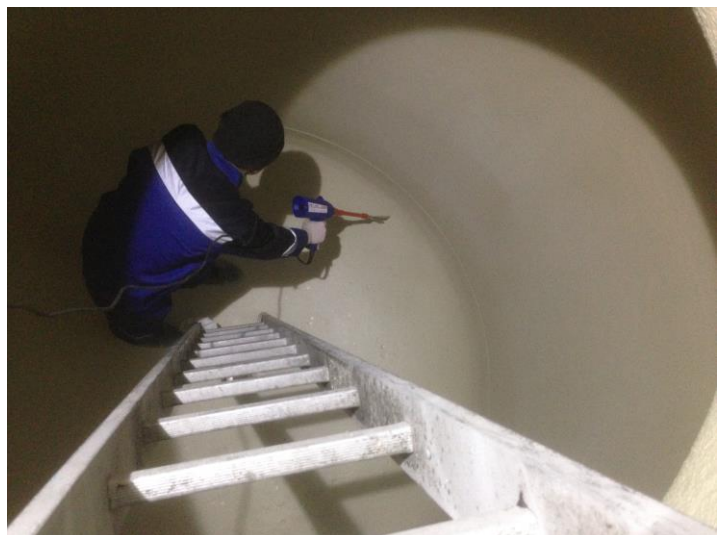
Final quality control inspection:
