CORROCOAT CASPIAN

CASE STUDY

<u>Customer:</u>	Pavlodar Energo (Power station # 3)
<u>Equipment:</u>	Brick and concrete cell for liquid coagulant
<u>Location:</u>	Pavlodar, Kazakhstan
<u>Dates:</u>	August 26 – September 07, 2018
<u>Environment:</u>	FeSO ₄ (10-60% concentration), temperature +20-40°C
<u>Surface area:</u>	110m ²
<u>Materials:</u>	Polyglass WCP (wet-concrete) primer (at 150 microns) and a vinyl-ester glassflake Polyglass VE (1200 microns)

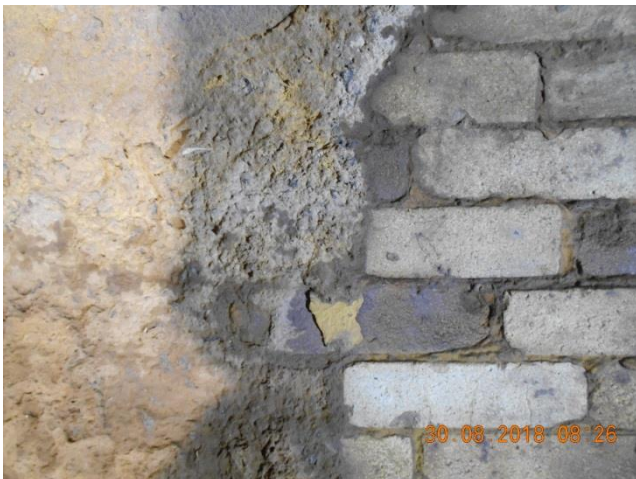
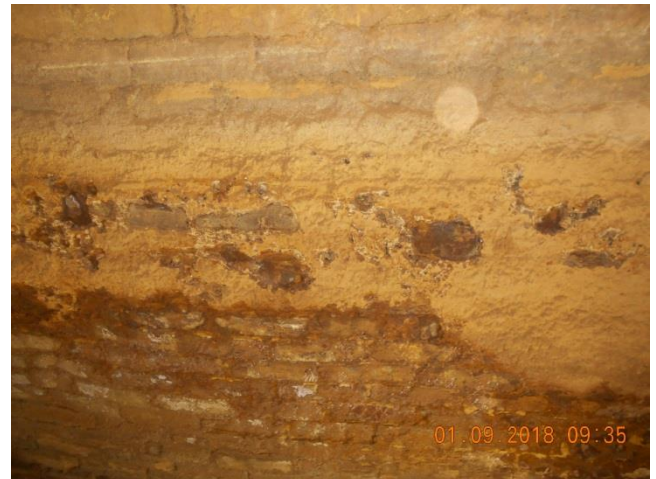
Damaged surface of the cell before repair and coating:

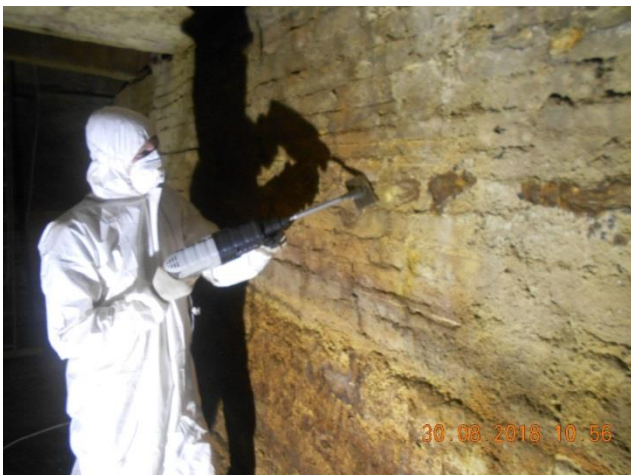
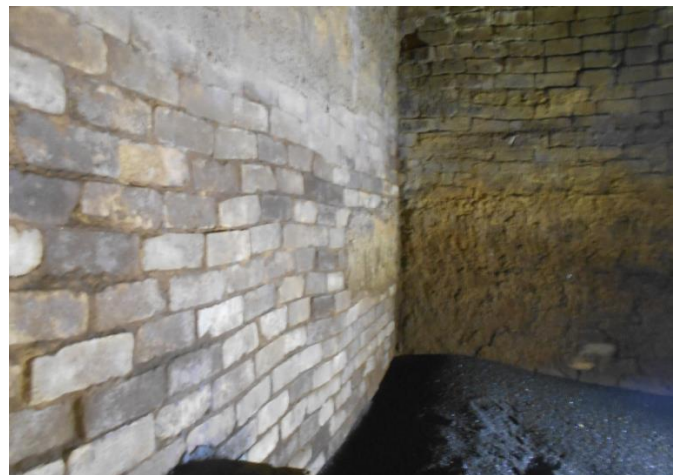
Manual cleaning and blasting of the surface:

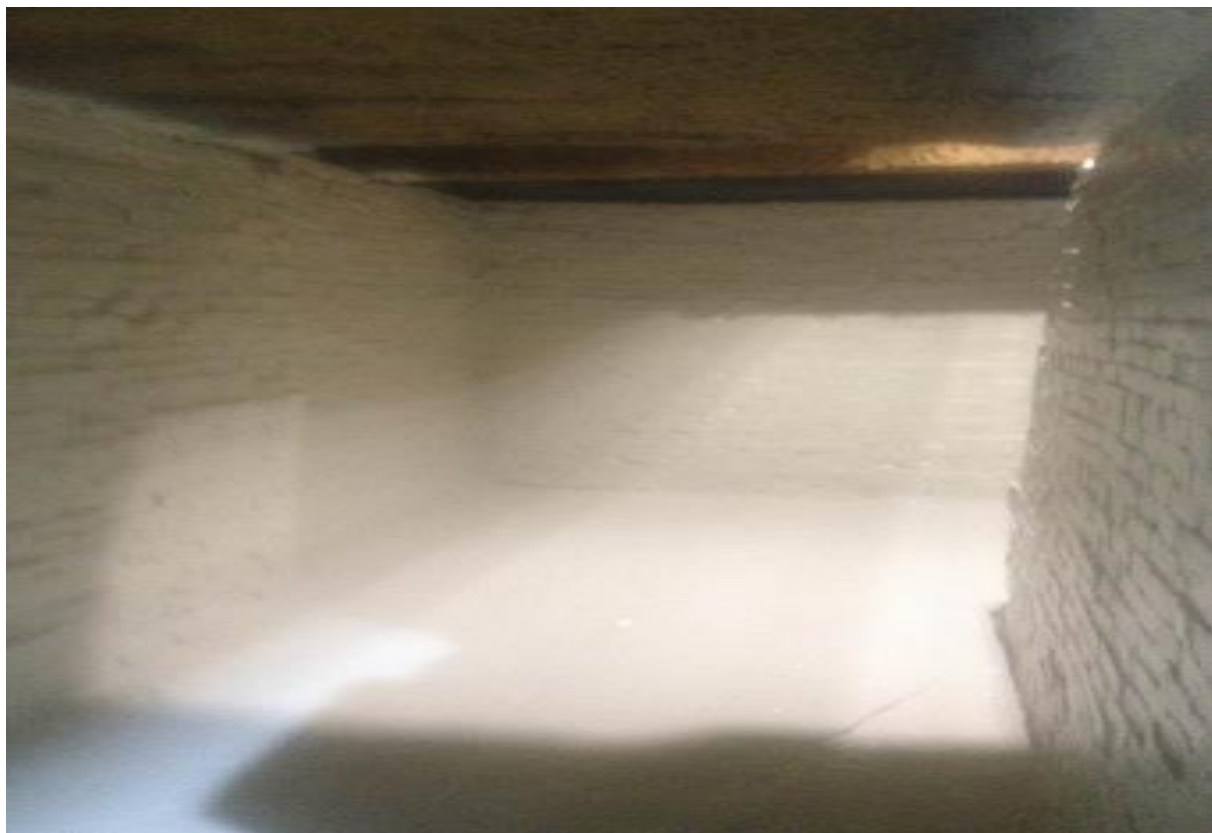
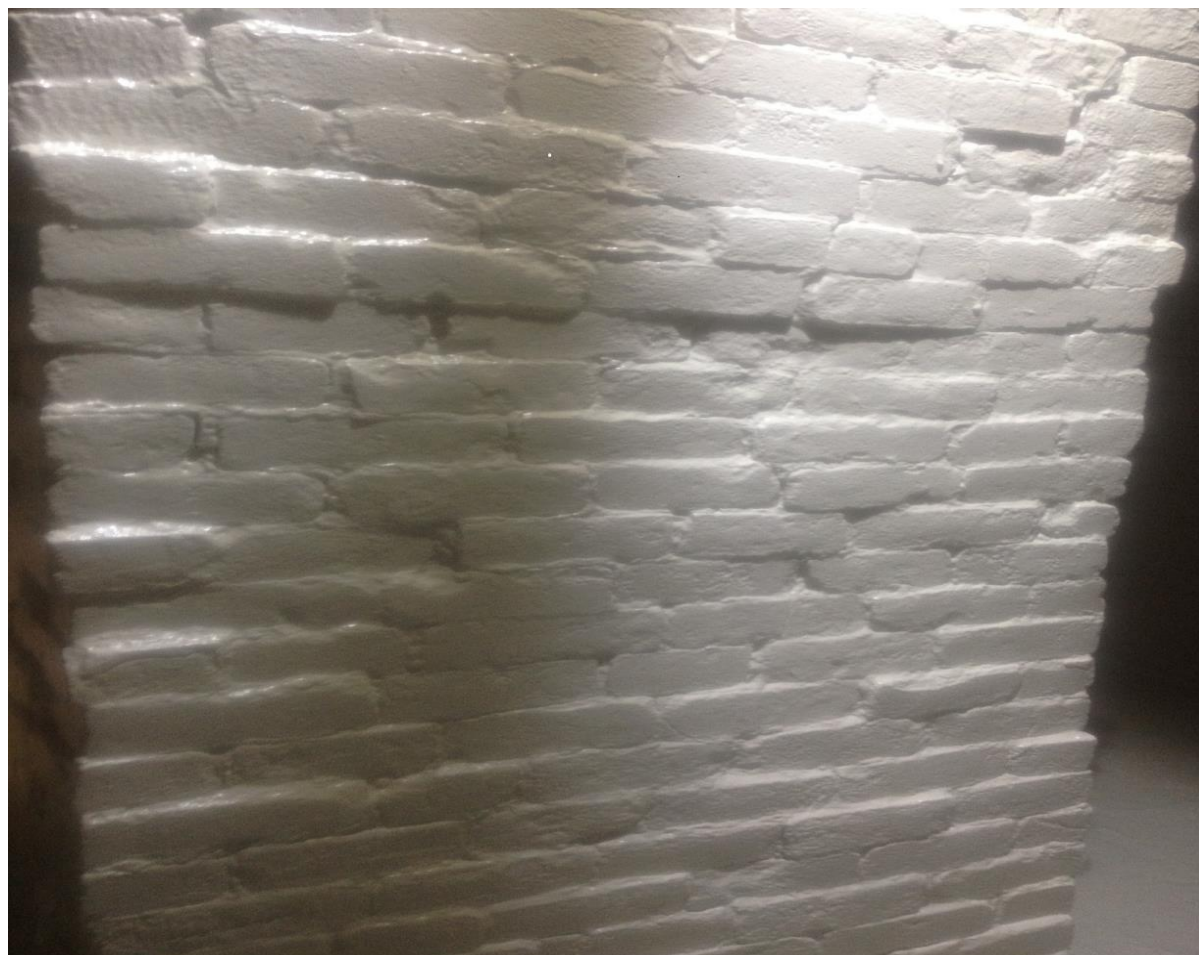
After application of Polyglass WCP primer (150 microns) and Polyglass VE coating (1200 microns):
