CORROCOAT CASPIAN

CASE STUDY

<u>Customer:</u>	Almaty Yeast Plant
<u>Equipment:</u>	Orthophosphoric acid pump (73% acid concentration)
<u>Location of the job:</u>	Corrocoat Caspian facility, Almaty, Kazakhstan
<u>Materials used:</u>	Corroglass 600 series, Polyglass VEF
<u>DFT:</u>	1500-3000 microns
<u>Date:</u>	April 2017

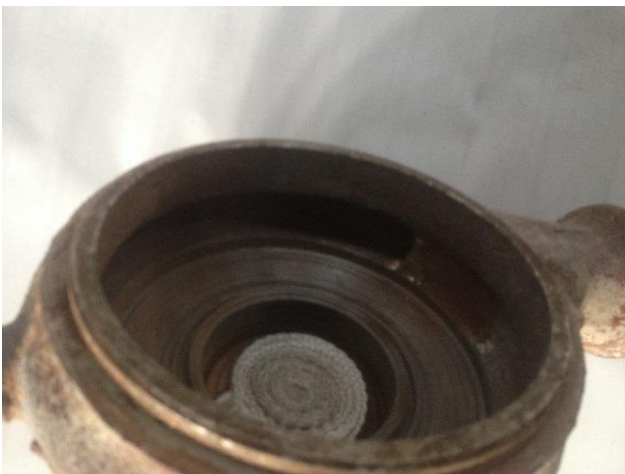
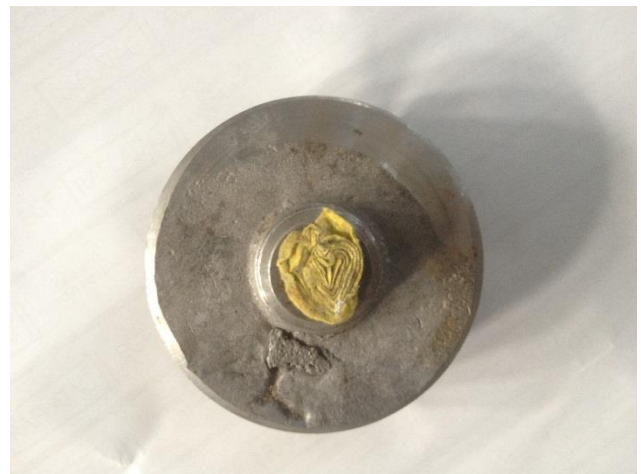
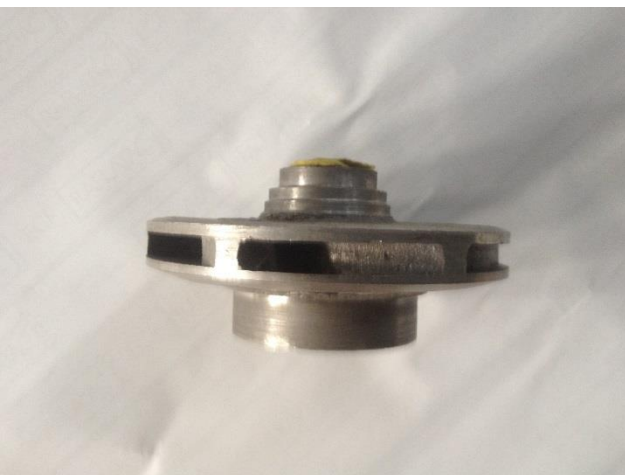
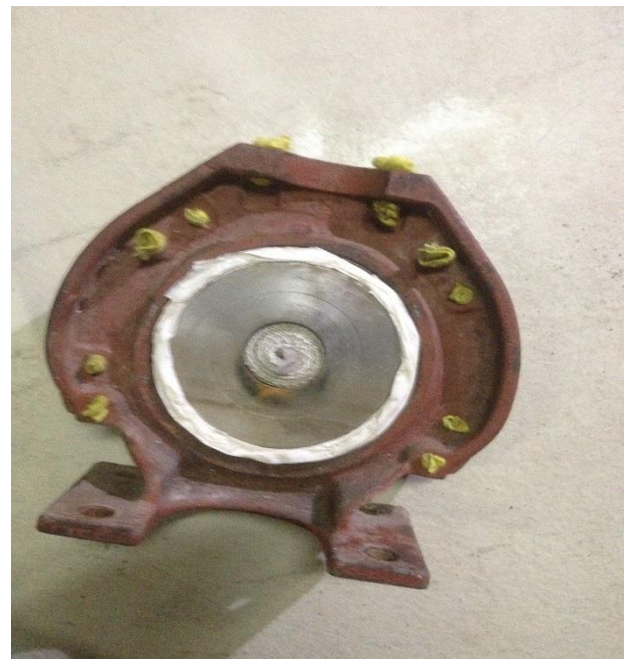
The pump with acid corrosion and erosion before the refurbishment:

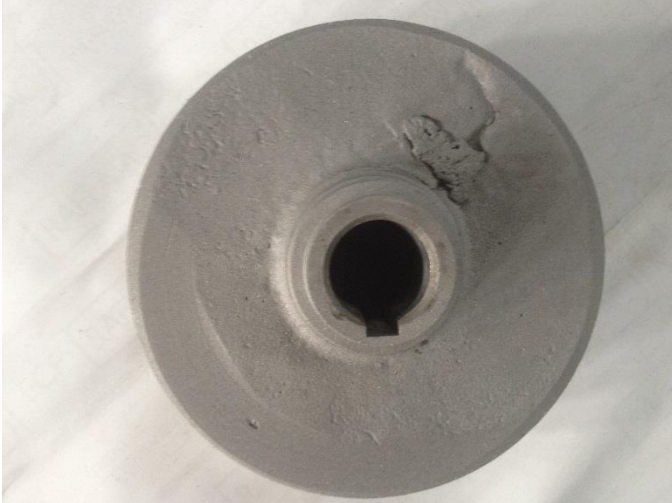
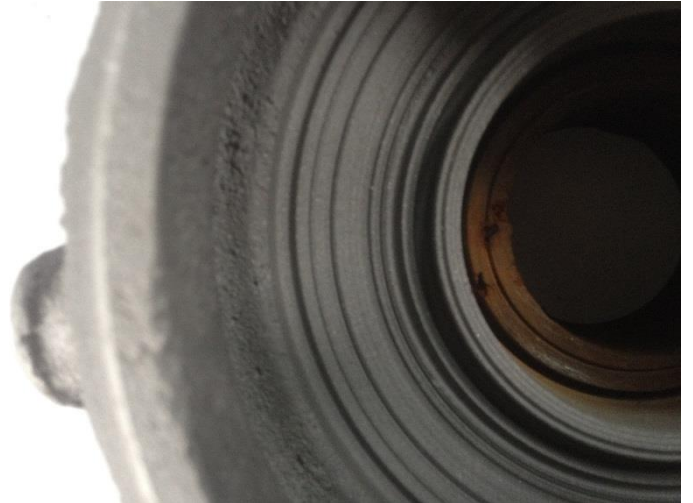
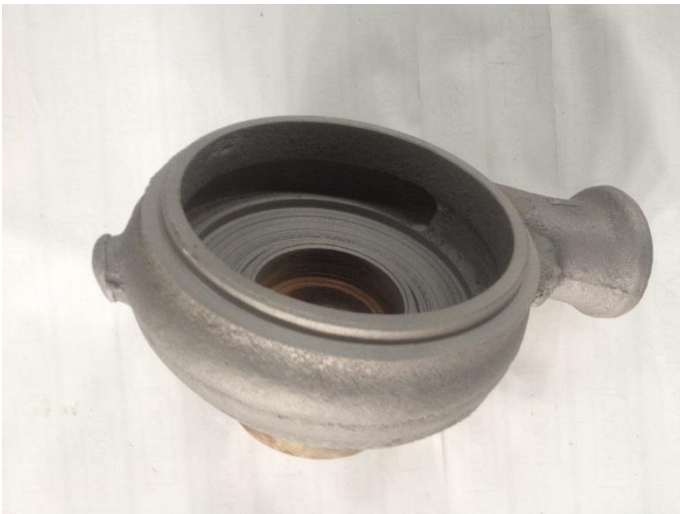
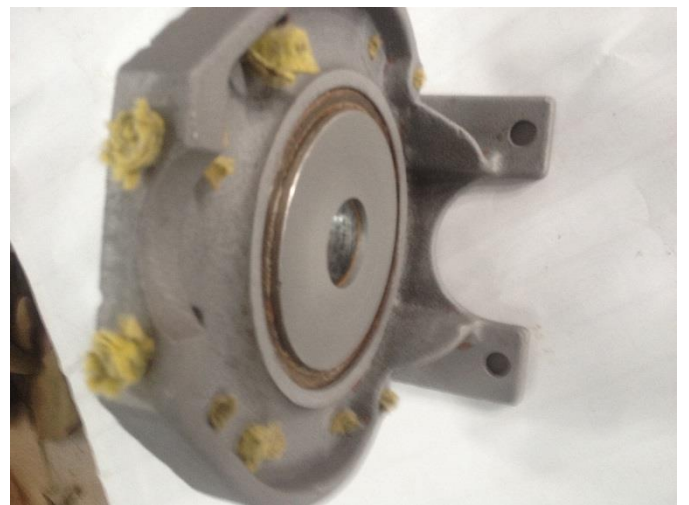
The pump after blast cleaning and ready for the refurbishment:
